Figures 1 – 5: Maps and Design Drawings of Aravaipa Creek Fish Barriers

Figure 6a – I: Araviapa Creek Fish Barrier Construction Photos

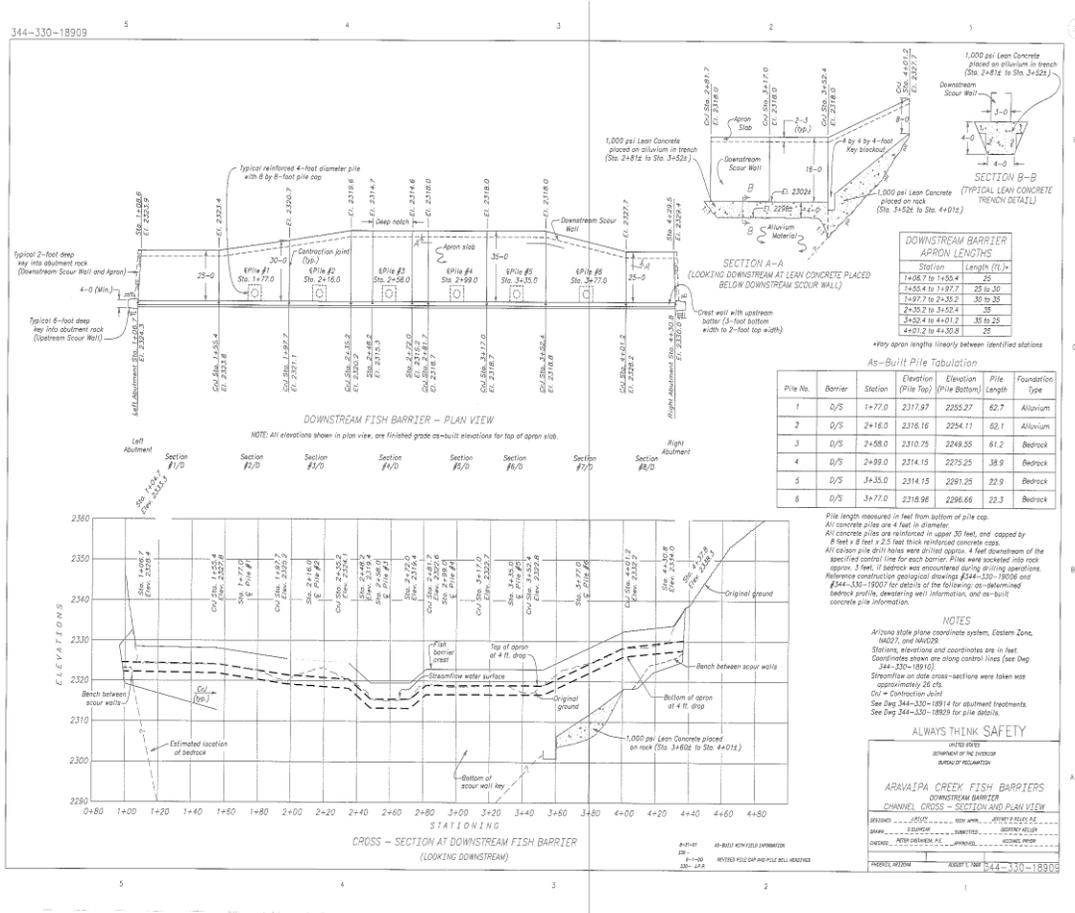
Figure 3. Channel cross-section and plan view of downstream Aravaipa Creek barrier.

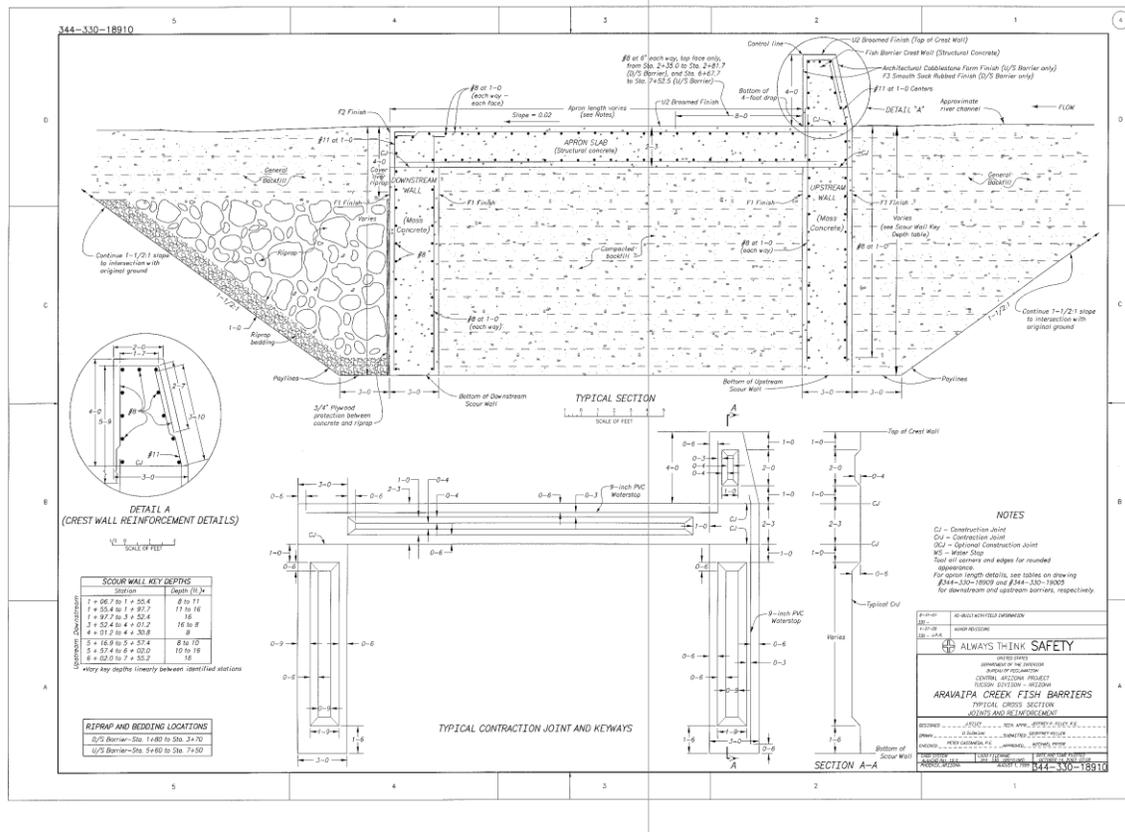
Figure 4. Typical cross-section joints and reinforcement for Aravaipa Creek barriers.

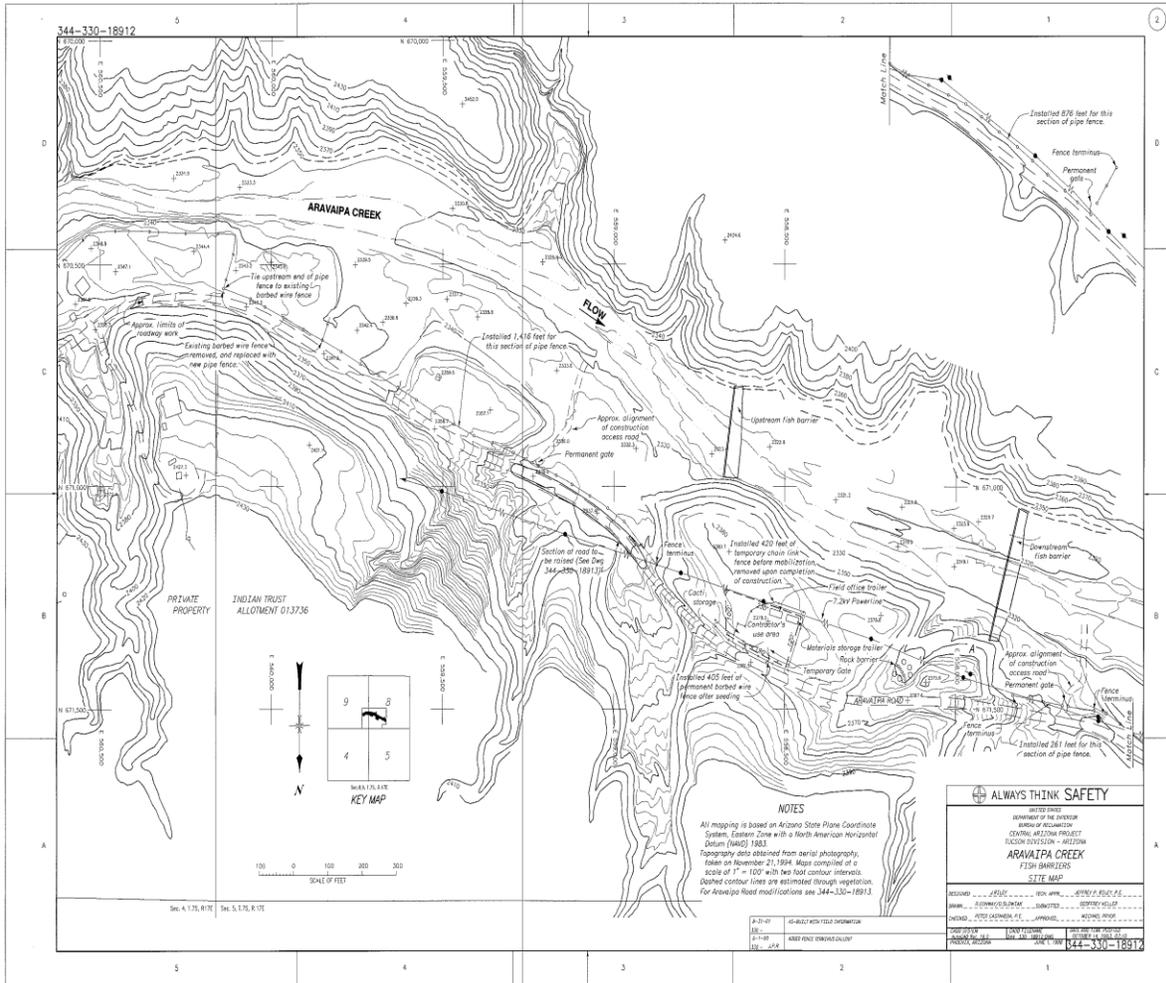
Figure 5. Aravaipa Creek barrier site map.

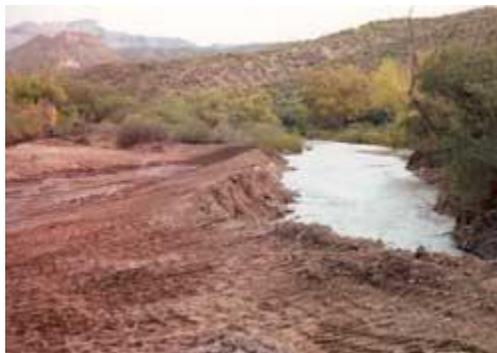
Figure 6b. A diversion channel was constructed to divert the existing stream flows.

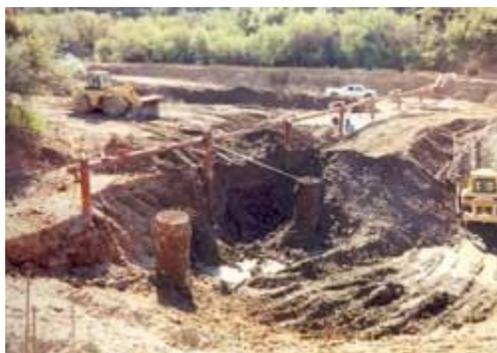
Figure 6c. Dewatering well system pumps discharge water into the diversion channel.

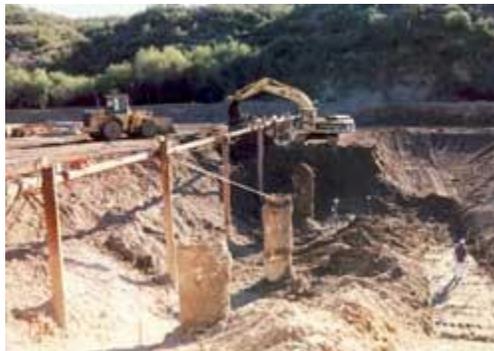
Figure 6e. Trench excavation around the reinforced concrete piles.

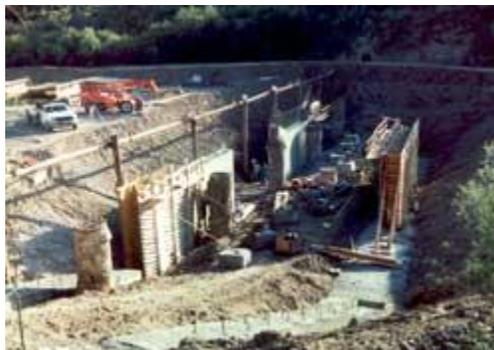
Figure 6f. Reinforced concrete scour walls were constructed to prevent erosion of the stream's substrates.

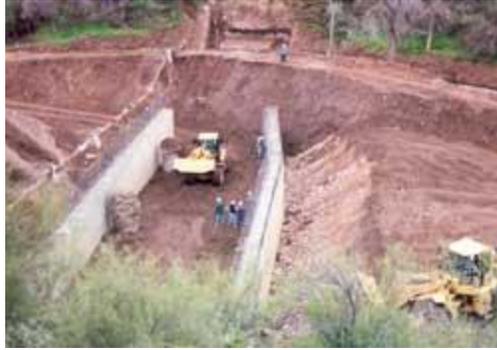
Figure 6g. Backfilling of the structure.

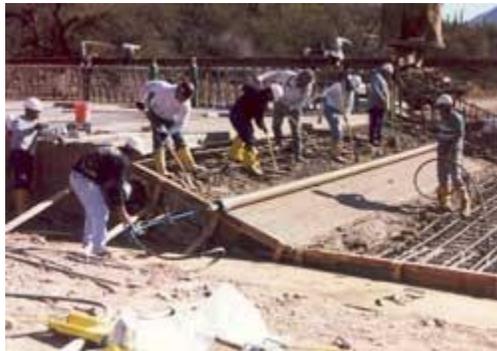
Figure 6h. Placement of the reinforced concrete apron slabs.

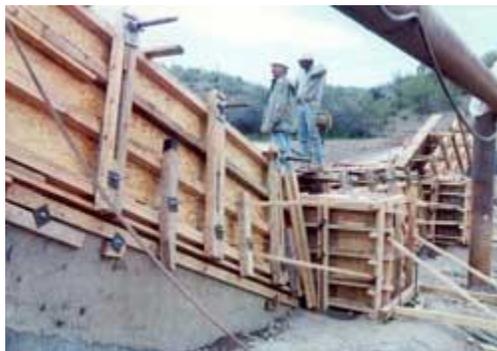
Figure 6i. Reinforcing the concrete drop crest walls.

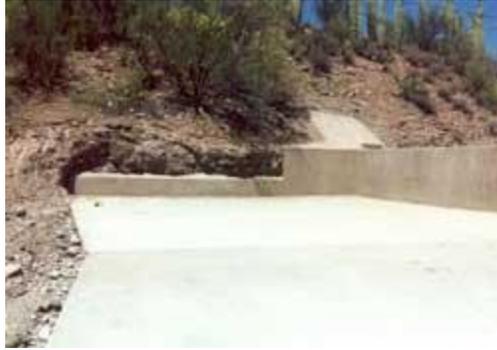
Figure 6j. Right abutment of the barrier structure.

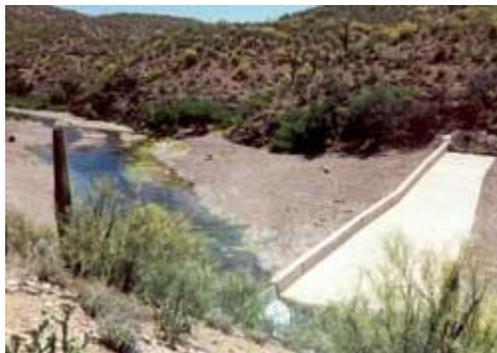
Figure 6k. Side-view of completed barrier.

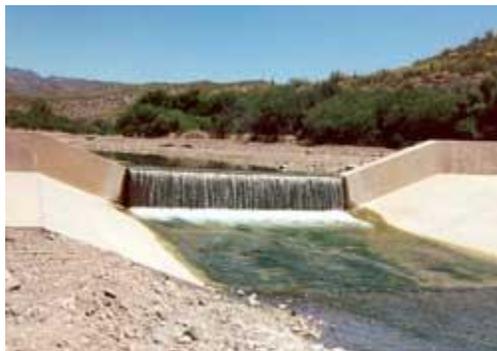
Figure 6k. Front-view of completed barrier.
